Fall of a suspended load, resulting in injuries to two crewmen on board the general cargo vessel *ZEA Servant* in Campbeltown, Scotland on 2 March 2019

SUMMARY

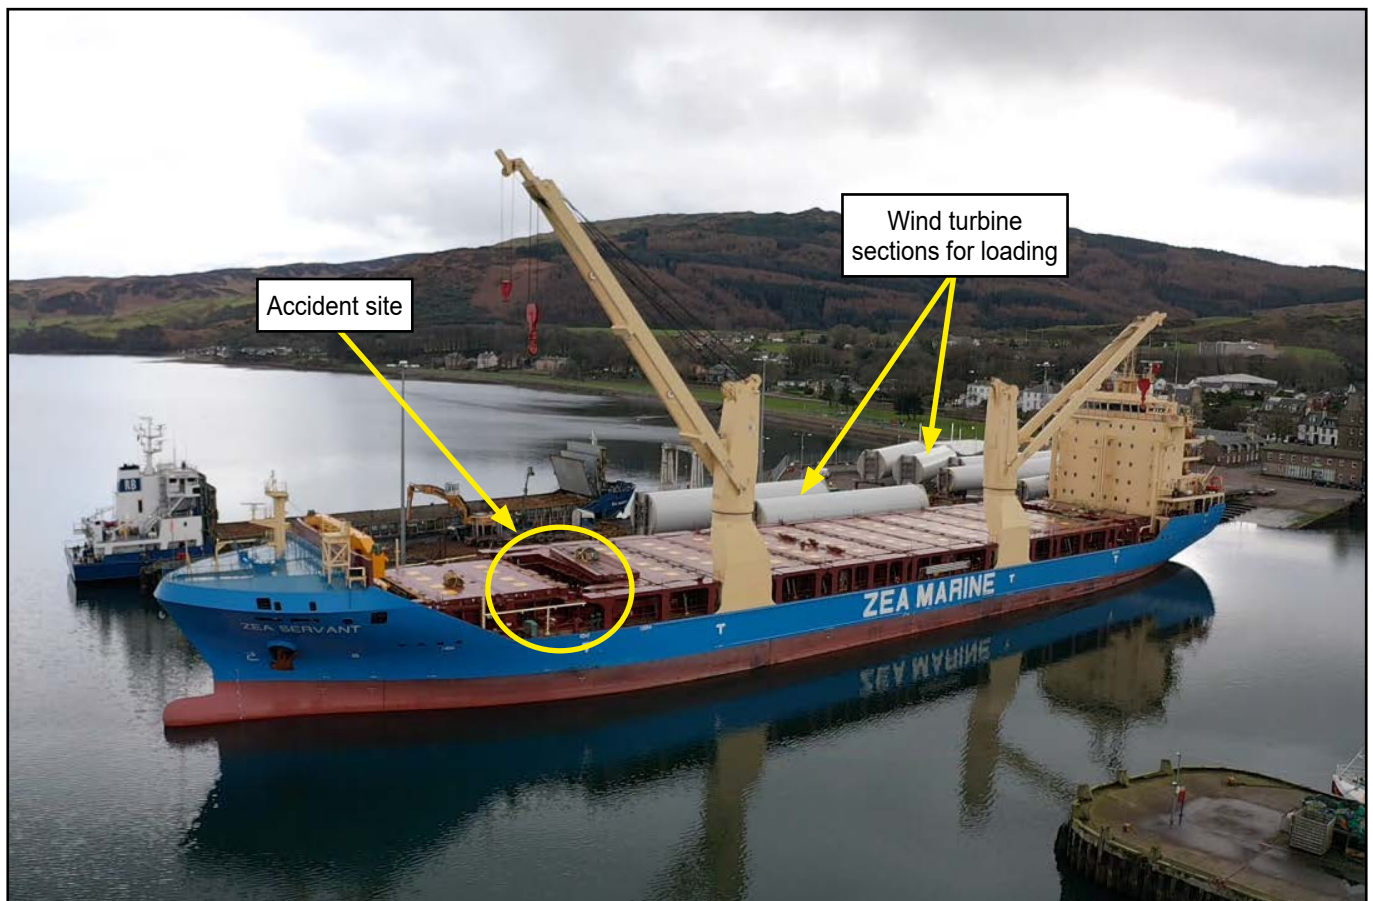
ZEA Servant arrived in Campbeltown, Scotland on 1 March 2019 to load a cargo of wind turbine tower sections (**Figure 1**). On 2 March 2019 the deck crew, supervised by the chief officer, began preparing the vessel for cargo loading. This work was halted in the afternoon due to adverse wind conditions, but was scheduled to recommence later in the evening when the weather was expected to improve. At 2100, the chief officer held a safety briefing and took up position as supervisor, accompanied by the bosun. By this time, the wind was light, and it was dark and dry; the vessel's deck working lights were on, illuminating the area where the crew were working.

Figure 1: *ZEA Servant* berthed in Campbeltown showing accident site and wind turbine sections for loading

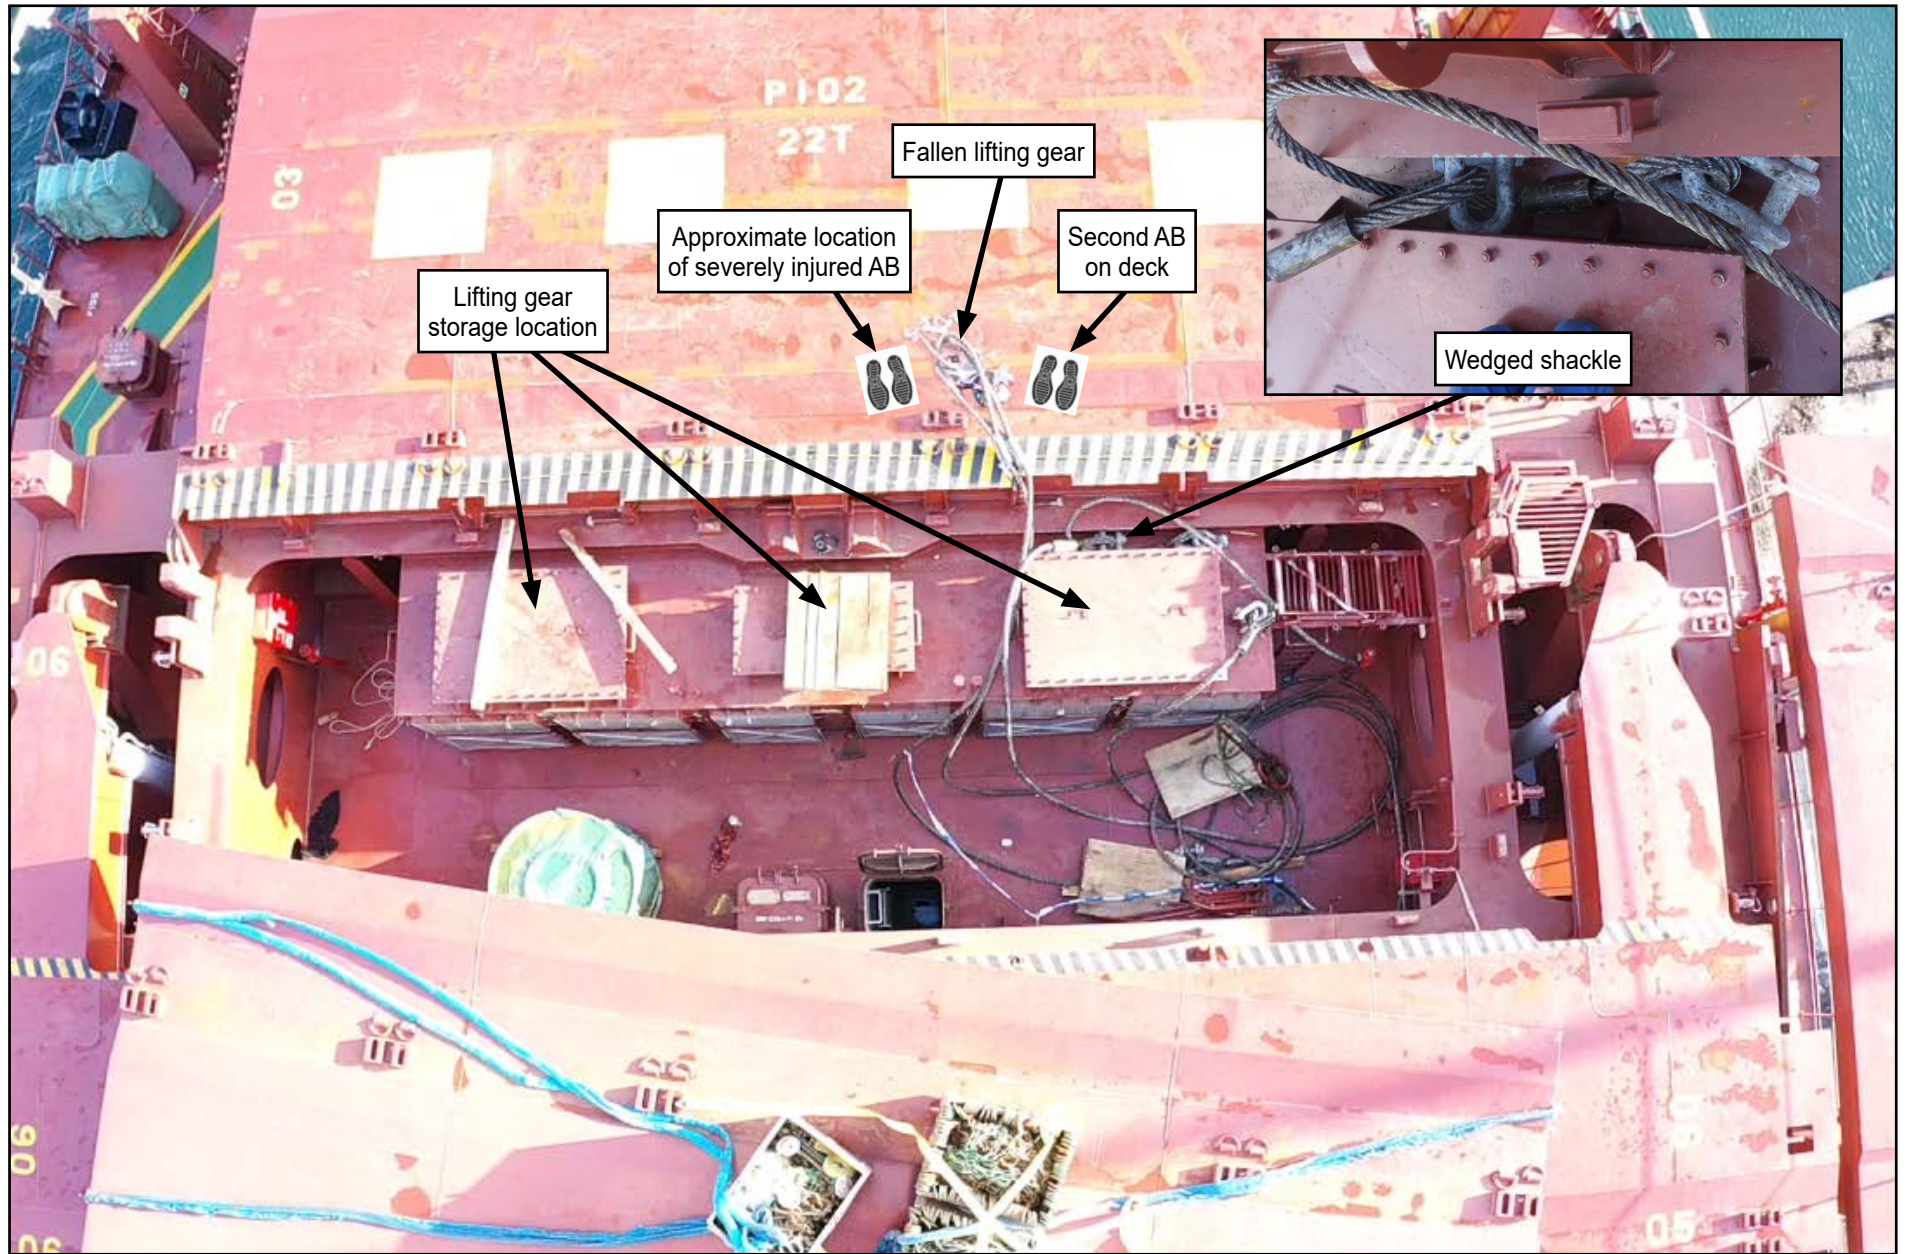
Shortly after the lifting operation recommenced, a shackle at the lower end of the load became snagged on a ventilation trunk coaming (**Figure 2**). The chief officer immediately instructed the crane driver to stop, but at the same time the fibre sling parted and the lifting gear fell to the deck, striking both ABs.

Figure 2: Plan view of the ventilation duct space and accident site (inset: close up of wedged shackle)

ZEA Servant had not been built with a dedicated storage area for the heavy cargo hold hatch cover lifting gear. As a result, the crew had devised a local arrangement to store the lifting gear on top of wooden pallets in the cargo hold ventilation duct space (**Figure 2**). This might have appeared appropriate as a suitable storage space because it was accessible; however, it was an area where there was a significant number of potential snagging hazards, especially for lifting slings with shackles at their ends.

- *ZEA Servant* was not fitted with a dedicated storage arrangement for the cargo hatch lifting gear, and the practice of placing it on pallets in the ventilation duct space was not appropriate, due to the snagging hazards.

- Identified an alternative and more suitable location to stow the cargo hold hatch cover lifting gear and developed a lifting plan for its removal and re-stowing.
- Notified its fleet of the importance of crew safety awareness, including the need for self-protection measures and safe positioning during lifting operations.
- Notified its fleet of the importance of the safety brief and the responsibilities of those supervising lifting operations.
- Undertaken a review of the vessel's safety management system.
- Provided additional safety training to *ZEA Servant's* crew on the procedure to open hatches and the inspection of lifting equipment.
- Issued a fleet circular requiring checks to lifting equipment, including SWL of each component, certification and the condition of fibre slings.
- Required shore managers to inspect operational safety of crew.

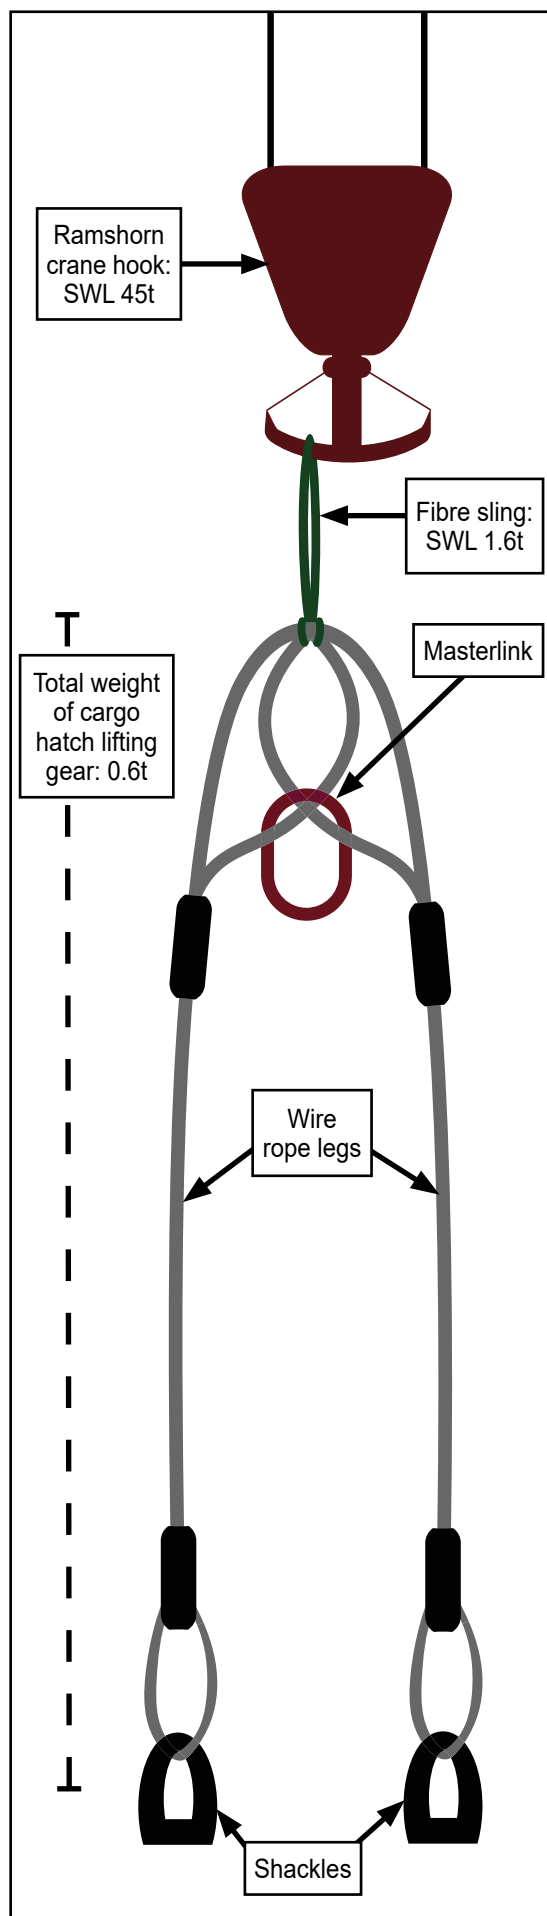
ZEA Servant's forward crane had a safe working load (SWL) of 250 tonnes (t), and its ramshorn hook had a SWL of 45t. The crane was in date for survey and had no known defects. The cargo hold hatch cover lifting gear was made up of two slinging sets; each set weighed 0.6t and consisted of two 17m long, 52-millimetre (mm) diameter, wire rope legs joined together with a master link (Figure 3). Each wire leg had a shackle attached to an eye at the lower end.

Figure 3: Cargo hold hatch cover lifting gear - attachment to crane hook with fibre sling

The crew used fibre slings to connect the hatch cover lifting gear to the crane's ramshorn hook because of the weight of the gear and the restricted amount of space around the ventilation coamings. The crew had used the same method to remove the lifting gear from the ventilation duct space on at least five previous occasions and had experienced similar snagging events. When these had occurred, the deck crew had manually freed the gear after the crane had stopped hauling.

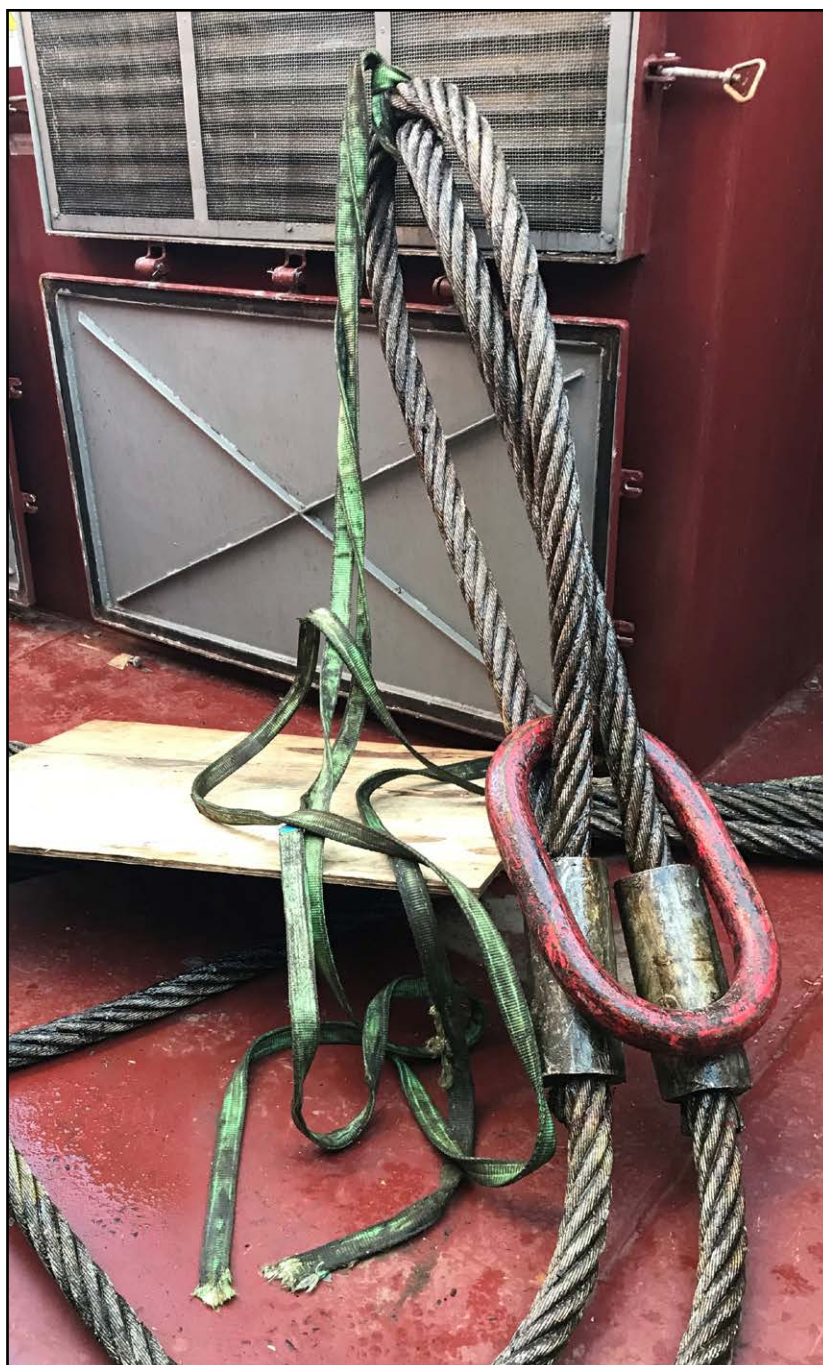
The fibre sling that parted (**Figure 4**) had been rigged using a choke hitch; it was one of several similar slings on board and had an SWL of 2t with a factor of safety of 6:1. This equated to a minimum breaking load (MBL) of 12t in a straight pull. These values reduced to 1.6t SWL and 9.6t MBL in a choke hitch configuration.

After the accident the parted sling (**Figure 4**) and five other similar slings from *ZEA Servant* were examined at an expert testing centre. The report of these tests stated that all six slings would have failed a visual inspection as they were soiled and had illegible identification markings. The parted sling was also noted to have some localised damage. During destructive testing, one of the other fibre slings failed at a load of 6.4t when rigged in the choke hitch configuration. The test laboratory report estimated that the actual breaking load of the parted sling at the time of the accident would have been 6.25t.

Figure 4: Broken fibre sling (after the accident)

The load fell because the synthetic fibre sling used to lift it parted under tension. It was reasonable to use such a fibre sling as its SWL was more than twice the weight of the load being lifted when rigged using a choke hitch. However, the fibre sling in use was in a poor condition, with local damage, soiling (**Figure 4**) and illegible identification markings. It therefore should have been discarded. Destructive load tests and laboratory analysis showed that its residual strength was almost half its design MBL.

- A formal task-specific risk assessment and lifting plan had not been carried out for the handling of the cargo hold hatch cover lifting gear.
- The SWL of the fibre sling that parted was sufficient for the lift, but it should not have been used and should have been discarded because its material condition was poor and its identification markings were illegible. The vessel did not have a comprehensive lifting equipment register; the onboard records did not include all of the loose lifting gear.

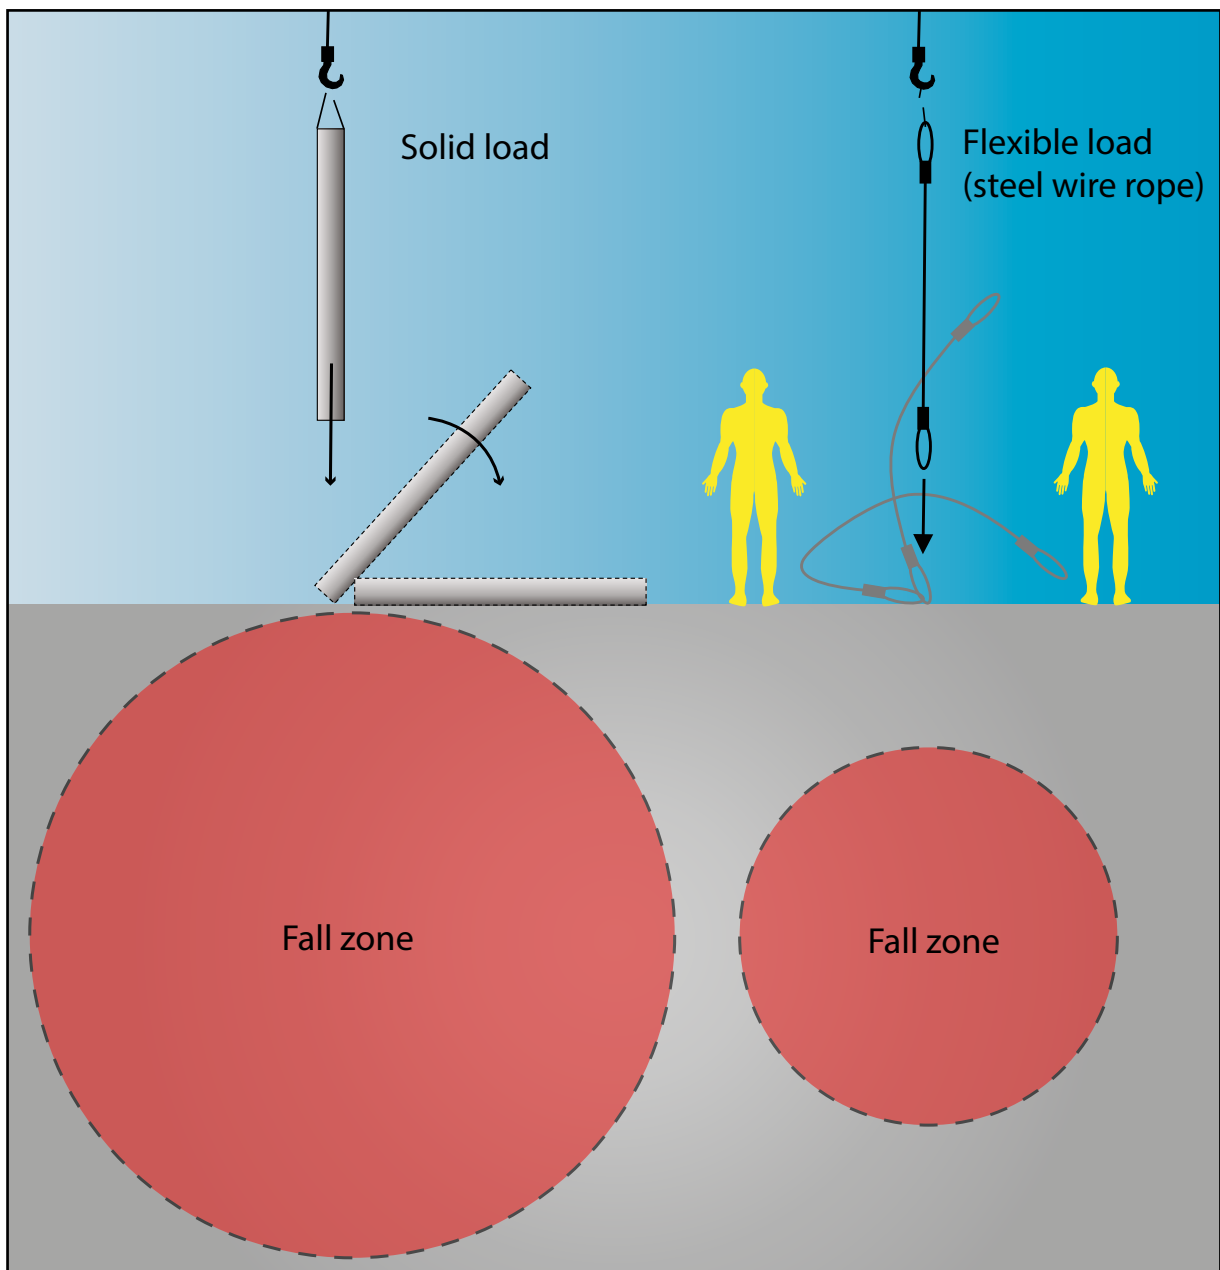
All lifting operations should be properly risk assessed and planned, and safe systems of work put in place. Lifting plans and safe systems of work should address the foreseeable risks involved in the work and identify all the appropriate resources necessary for safe completion of the task. Factors to consider when developing a lifting plan include: appropriate equipment, suitably qualified personnel, rigging arrangements, lift route, other proximate hazards, visibility, weather and an assessment of the fall zone (**Figure 5**).

The fall zone is not limited to the immediate area directly beneath the load; instead it is the reasonably foreseeable area that partially or completely suspended loads could fall into in the event of an accident. Solid loads can bounce, roll, topple over or fragment in any direction on impact with the ground. Flexible loads, such as steel wire ropes, will collapse into an area dependent on their stiffness of the wire ropes (**Figure 6**). Having assessed the hazards and resources, the plan should then set out clearly the actions involved at each step of the operation and identify the responsibilities of those involved.

Figure 5: Illustration of the fall zone around a suspended load

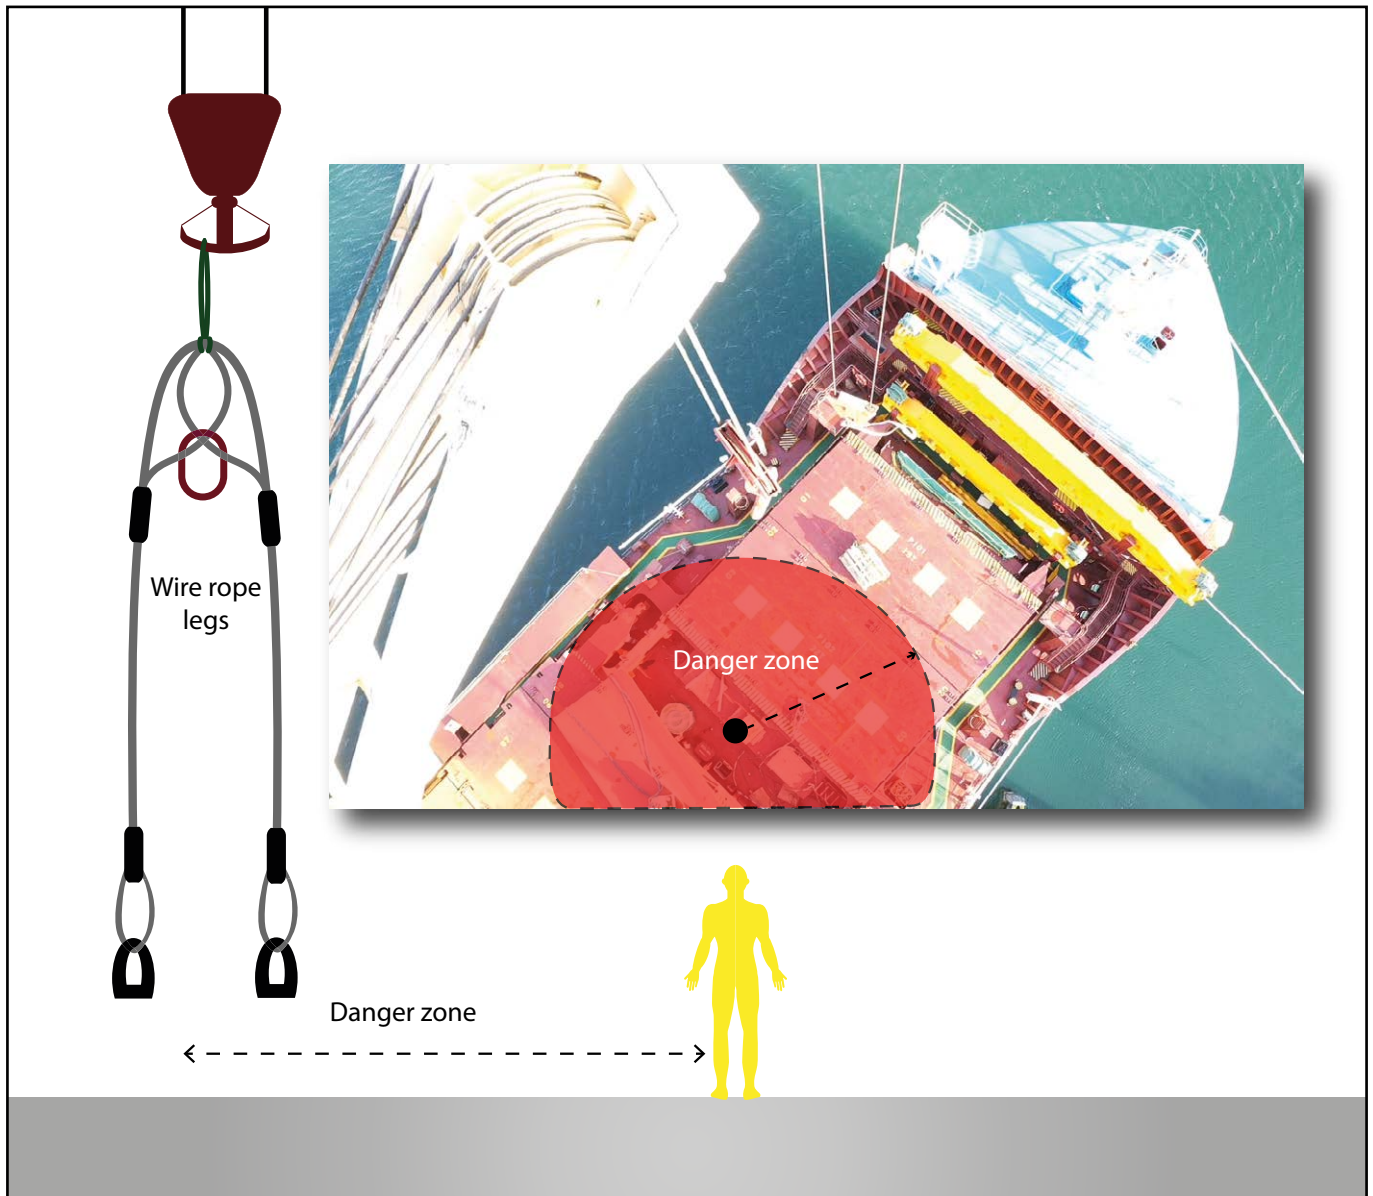
ZEA *Servant*'s safety management system did not contain a risk assessment or a procedure for the stowage and handling of the cargo hold hatch cover lifting gear, nor any guidance for the conduct of a lifting plan and the identification of fall zones. Had a fall zone assessment been undertaken, it would have been evident that it was unsafe for the crew to position themselves so close to the suspended load.

Figure 6: Illustration of the estimate of the danger zone that the lift would have created on board *ZEA Servant*
