## SAFETY INVESTIGATION REPORT

REPORT NO.: 05/2021

### **MV TITANIA** **Serious injury to crew member** **while operating the on board lathe** **in position 35° 43.7' N 075° 10.5' W** **04 February 2020**

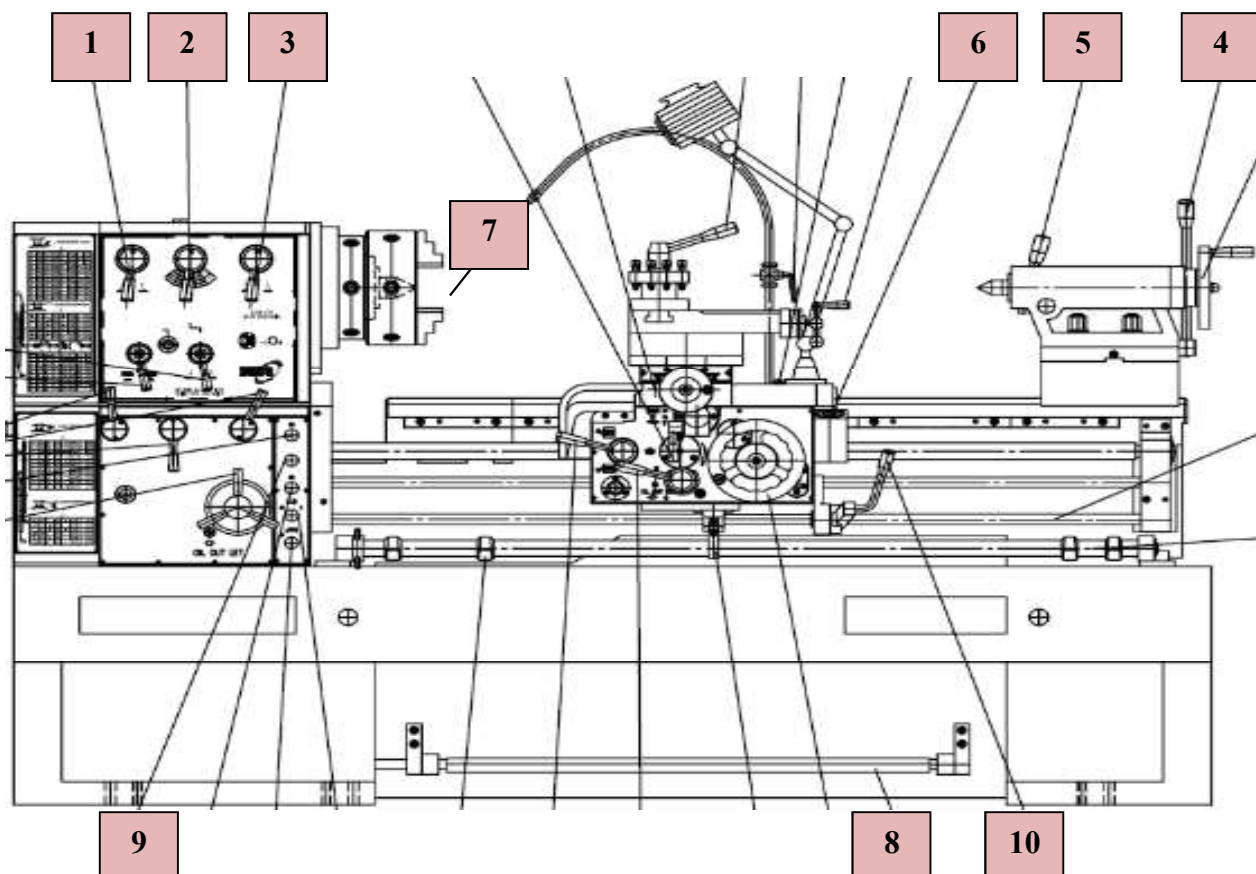
**Figure 1: The lathe on *Titania***

The lathe was a DMTG CDL6251/1500 model. Figure 1 shows the various features and operating functions which were of interest to the safety investigation:

1. speed selecting lever;
2. spindle speed selecting lever;
3. high-low speed selecting lever;
4. tailstock sleeve moving handwheel;
5. tailstock clamp lever;
6. tailstock sleeve clamp lever;
7. three-jaw chuck (fitted at indicated location);
8. foot brake pedal;
9. emergency stop button; and
10. spindle control lever.

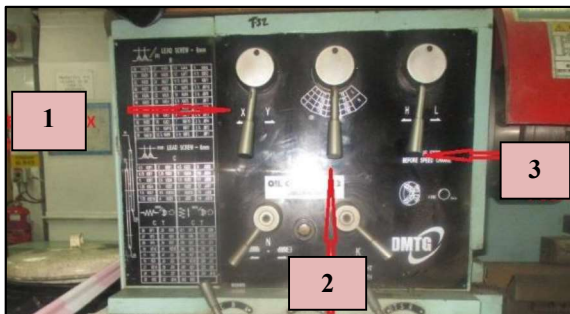
- the speed selecting lever 1 set on 'X' (Figure 2);
- the spindle speed selecting lever 2 set to middle (Figure 2);
- high / low speed selecting lever 3 set on 'H' (Figure 2)
- the speed control levers were found in the positions depicted in Figure 2;
- the tailstock was secured tightly on the guideway of lathe;
- the length of the rod outside the chuck until the end that was supported by the tailstock was 734 mm;
- the distance from the chuck to the tailstock centre pin was 732 mm;
- while testing, the tailstock sleeve moving hand wheel was rotated clockwise but was noticed to turn anti-clockwise under its own weight, withdrawing the sleeve by about 2 mm;
- the tailstock sleeve clamp lever was noticed to have not been fully secured;
- the depth of the drilled point at the end of the rod that was supported on the tailstock was about 1.5 mm;

Figure 2: Settings of control levers.

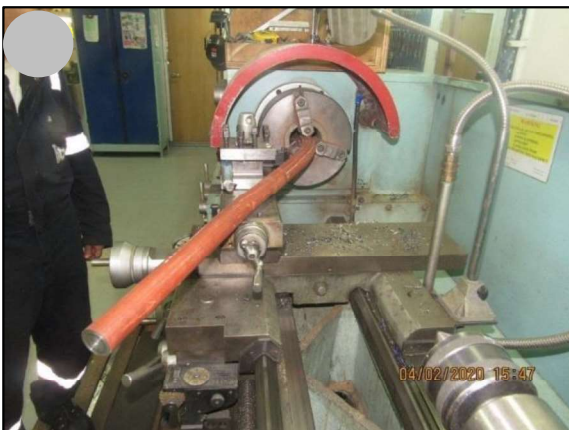
- no indentations were found on the rod, which could have indicated an axial shift of the rod in the three-jaw chuck.
- the rod was found bent (Figure 3).
- the tool post securing bolts were found broken (Figure 4).
- the chuck guard was found in a closed position (Figure 3).
- the spindle control lever was found in the lifted position (which would cause the spindle to rotate forward, *i.e.*, counter clockwise) (Figure 5).

Figure 3: Condition of rod after accident

The fitter was operating the lathe to machine a cast iron rod of 800 mm length and 35 mm in diameter. In the process, the rod slipped from the tailstock while the lathe was rotating at a very high speed. This caused the rod to bend and strike the fitter on his right shoulder region.

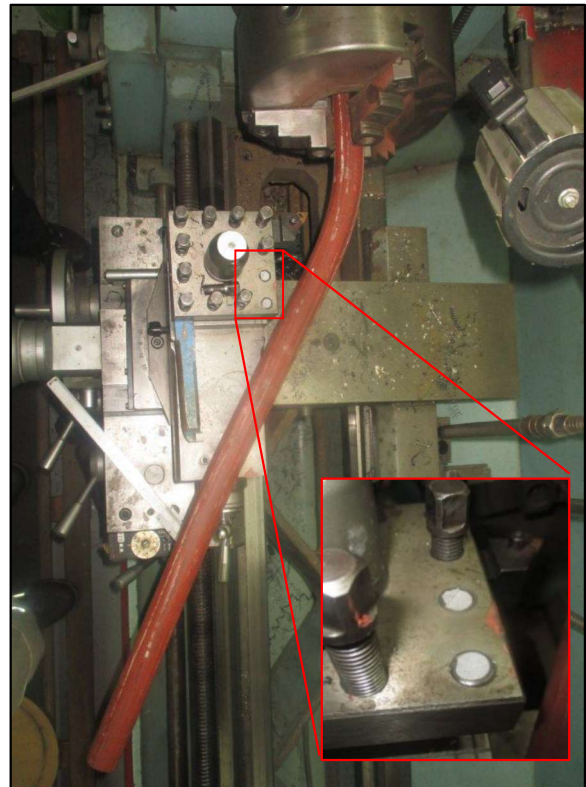
Figure 4: Tool post with two broken bolts

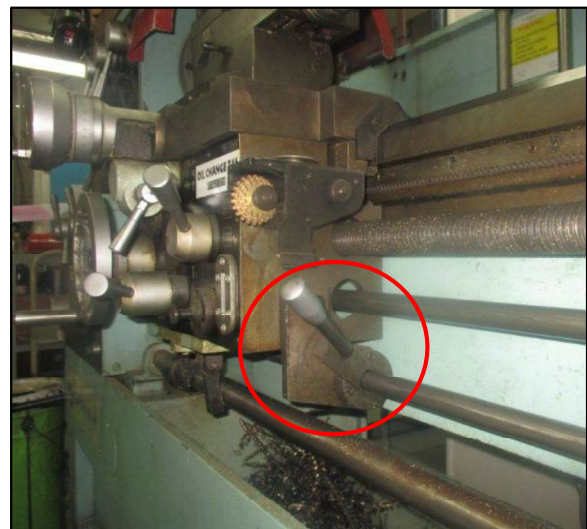
Figure 5: Spindle control lever in lifted position

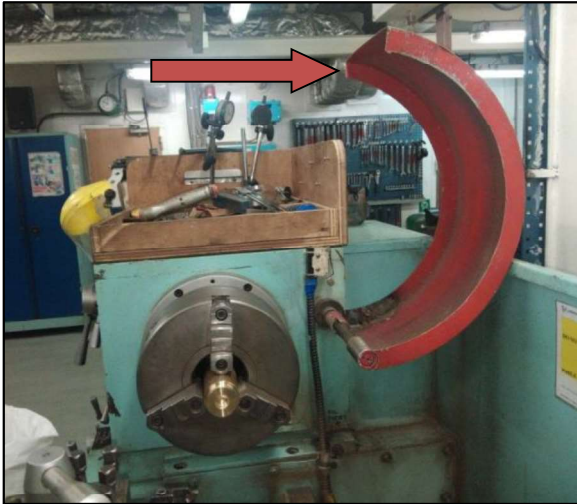
The fitter recalled being given a job order by the second engineer to fabricate a roller and shaft for the gangway. He also remembered centring the drilled hole on the rod in the lathe, sometime after 1310. He could also recall the open chuck guard (Figure 6), just

**Figure 6: Chuck guard in open position**

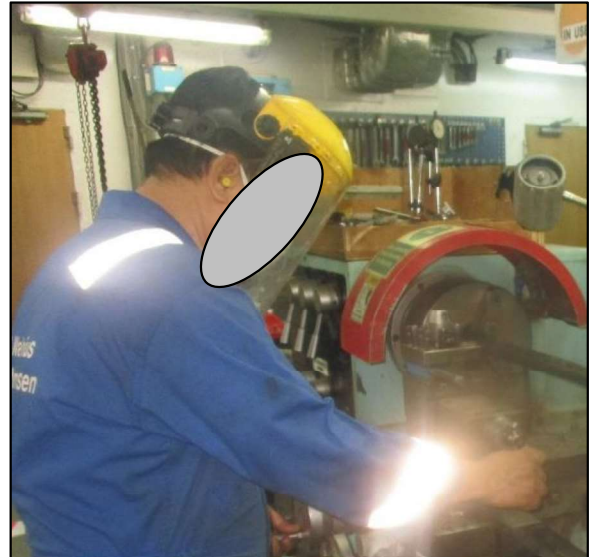
At the time of occurrence, it was reported that the fitter was wearing overalls, safety shoes, ear plugs, a dust mask and a face shield. The PPE matrix required a safety helmet and safety goggles to be worn. However, considering that the fitter was wearing a face shield, this did not necessitate the donning of safety goggles. Additionally, the type of face shield worn by the fitter was not designed to be used in conjunction with a safety helmet (Figure 7).

**Figure 7: Simulation of fitter wearing face shield**

The absence of a safety helmet may have contributed to the fitter's minor head injury.

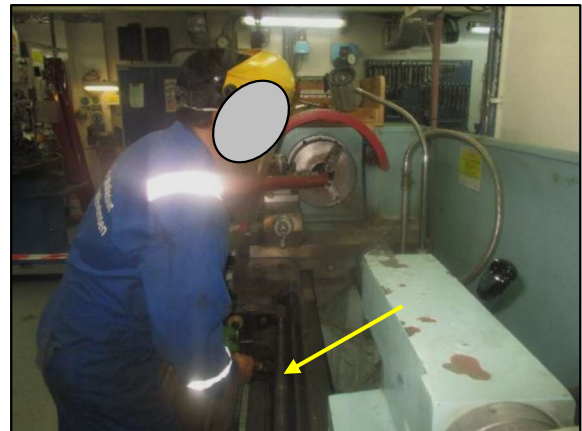
The possibility that the fitter may have tried to stop the rotational movement of the rod by operating the spindle control lever on the body of the lathe was also considered. While doing so, the fitter was struck by the rotating (and deflecting) rod on his right shoulder, knocking him on the floor, and hitting his head (Figure 8). This possibility was,

however, considered to be remote, given the short time that he would have had to react, unless he had noticed that something was not right with the rotating rod.

**Figure 8: A photo simulation of fitter intending to operate the spindle control lever (yellow arrow) and being hit by the rod on his right shoulder**

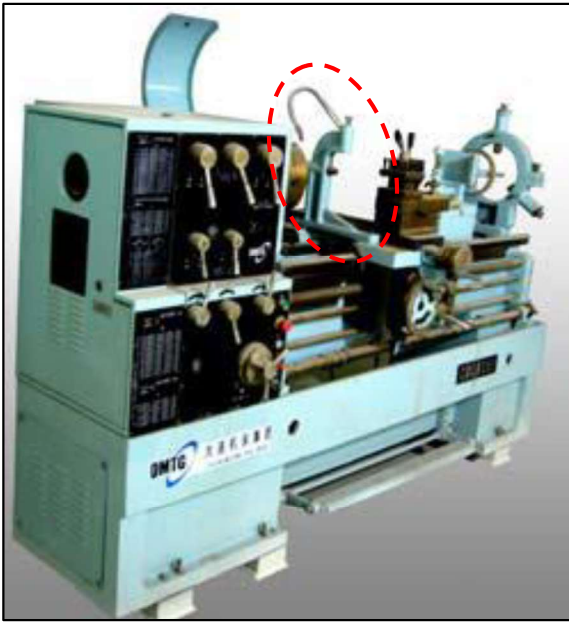
Taking into consideration the thickness of the solid rod (35 mm in diameter), it would have sufficed to use a follower rest for the task. Several long slender shafts that tend to whip and spring during machining, require the use of a follower rest. Follower rests (Figure 9)

are fitted on lathes to minimise excessive rotating deflections by holding long workpieces steady during machining. They are attached to the saddle (the lathe component that holds the tool post) and move along with or 'follow' the lathe.

**Figure 9: Follower rest installed on the lathe, as reproduced in the SMM**

Whilst the SMM did not indicate the minimum lengths of workpieces for which a follower rest would have been required, it transpired that a follower rest was not available on board.

- The Company confirmed that steady<sup>7</sup> and follower rests have been made available on board and were being used;
- A fleet wide experience exchange was carried out to ensure that the lessons learnt from this occurrence were promulgated and addressed.
