**Mooring line failure resulting in serious injury to a
deck officer on board
Zarga
alongside South Hook LNG terminal,
Milford Haven
on 2 March 2015**

MAIB SAFETY BULLETIN 1/2016

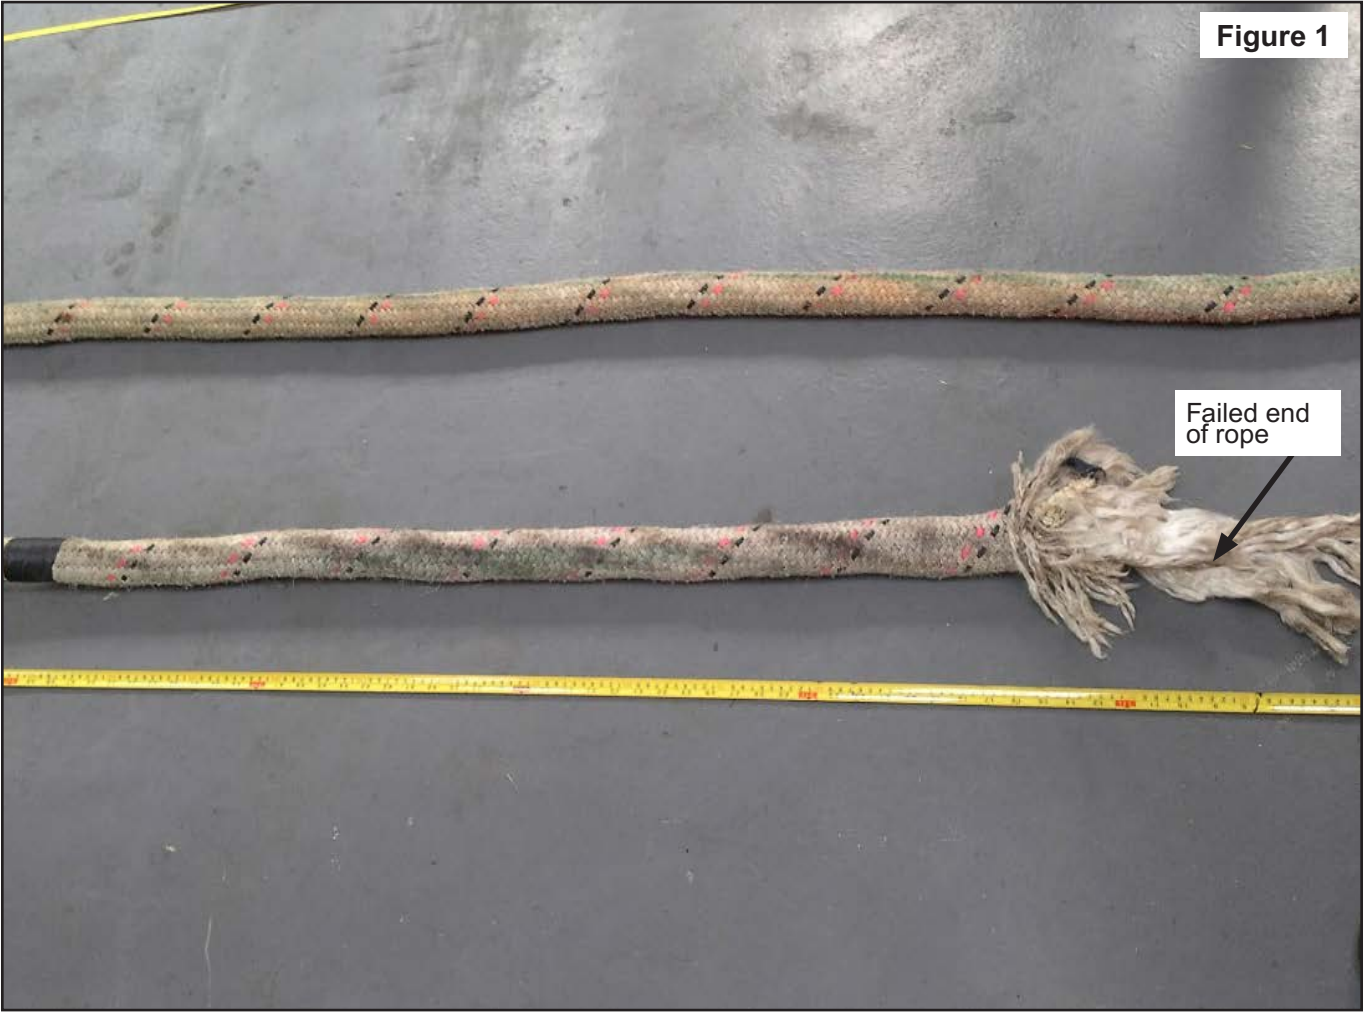
Figure 1

The rope failed at an indicative load of 24 tonnes. Subsequent non-destructive assessment of the rope by an industry expert did not identify any defects that would indicate that it had been used or operated incorrectly (**Figure 1**).

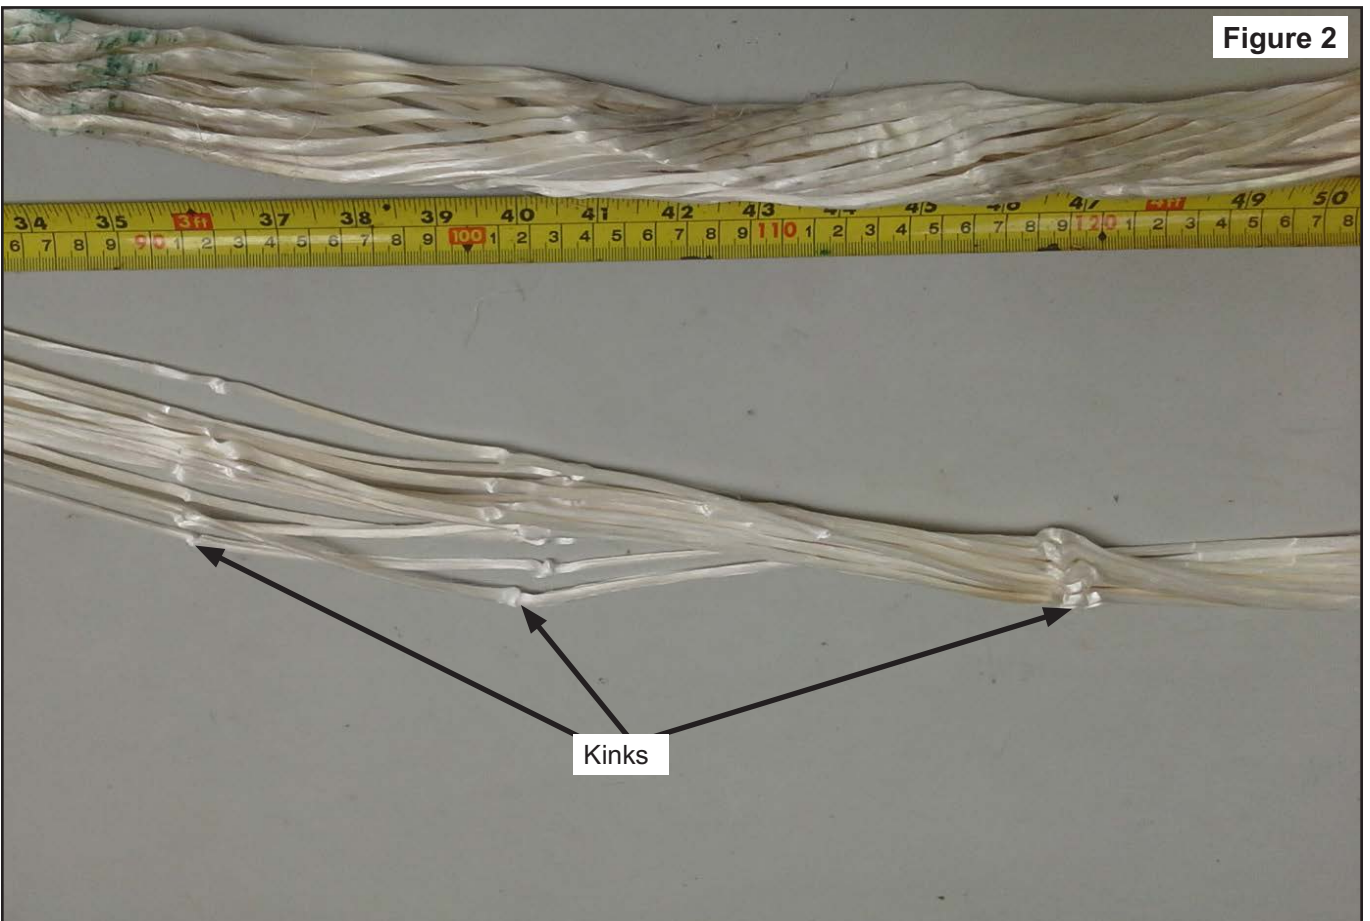
Figure 2

When the close-fitting jacket was removed from the rope at each side of the failure point, the rope yarns in all three strands exhibited moderate to severe kinking. The Z-shaped kinks were visually apparent and were found at close intervals with, for example, 22 occurring over a length of 2.78m (**Figure 2**).
