# MARS – Lessons Learned

## MARS Report No 373 November 2023

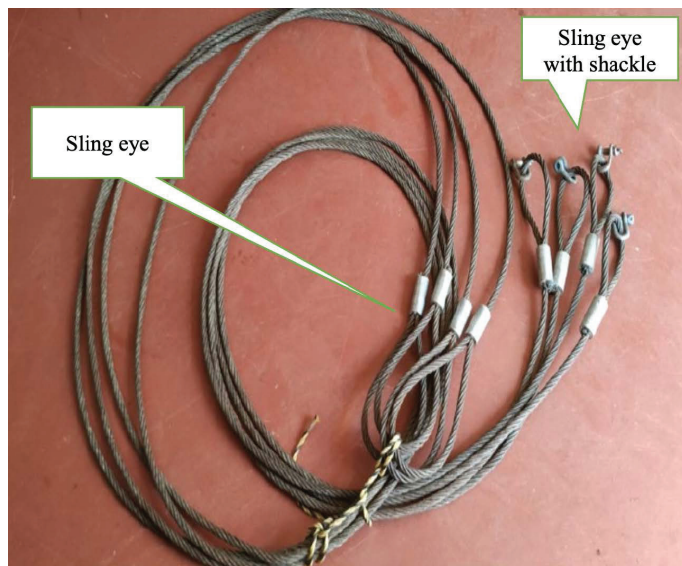
During the lifting operation the gangway was controlled by three people, each with a lanyard to guide the gangway. Two were on deck and one on shore. As the lift commenced, the outboard lifting slings were in tension and the inboard slings were slack. When the gangway reached the level of the deck rail, the inboard sling wires remained slack since the inboard end of the gangway was supported by the deck rail. As the outboard end of the portable gangway was lifted slightly above the deck rail, the tension of the outboard slings caused the gangway to swing inboard towards the vessel. This movement was enough to cause the two inboard slings to slip out of the crane hook and the end of the gangway immediately fell to the deck.

Sling eye

Sling eye with shackle

The investigation revealed that the information manual produced by the manufacturer of the portable gangway recommended the use of a composite lifting unit with a master link to connect the four wire rope slings to the crane hook. Had this practice been adopted, in conjunction with a spring-loaded safety latch, it is likely that this accident would have been avoided.

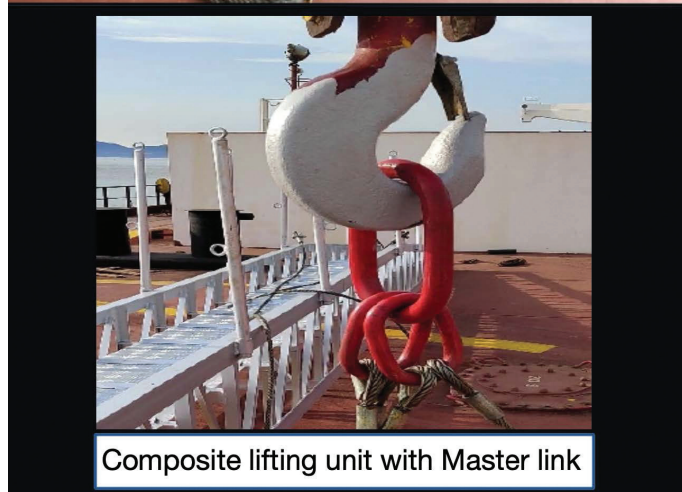
Composite lifting unit with Master link

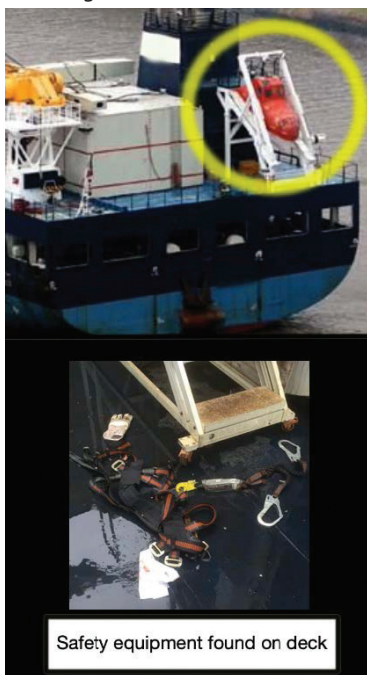
Safety equipment found on deck

The investigation concluded that it was likely that neither the safety officer nor the victims had consulted the manufacturer's information manual, as this edition specifically addressed the hazard encountered. In addition, it would appear that the necessary personal protective equipment (PPE) such as safety harnesses were not used as they were found lying on deck.

- Adherence to the on board safety procedures and other instructions available such as the manufacturer's information manual is a prerequisite for safe operations.
- A toolbox meeting and verbal preparation and instructions are best done at the work location to allow better understanding of the situation and a discussion of the hazards and mitigating strategies.
- Proper supervision is a key element for safer operations.

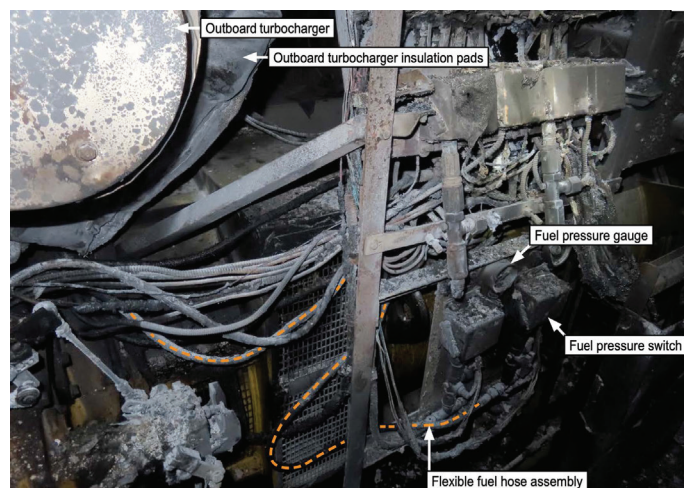
→ While departing port, a RoRo vessel suffered a fire in the auxiliary engine room. The fire was contained and subsequently extinguished without injury to the crew, but the equipment in the auxiliary engine room suffered serious damage. The fire originated below the outboard turbocharger when a small-bore flexible fuel hose failed, spraying marine gasoil (MGO) onto a high temperature surface, where it ignited.

The auxiliary engines had been modified many years earlier, when low pressure fuel alarm pressure switches and gauges were installed using flexible fuel hoses. This was contrary to MSC/Circ.647 – Guidelines to Minimize Leakages from Flammable Liquid Systems, which states that flexible hose assemblies should only be used where necessary to accommodate relative movement between fixed piping and machinery parts. In this case, flexible hose assemblies were not needed for this purpose. Furthermore, the hoses were routed under the turbochargers covered by the insulation pads, exposing them to the risk of contact with high temperatures and making them difficult to inspect.

Damaged auxiliary engine and flexible hose routing

For example, a rigid metal pipe secured with clamps and routed at an appropriate distance from the engine's exhaust might have been a safer option than flexible hoses.

- Flexible hoses have a higher risk of failure than a properly fitted metal pipe. An isolation valve fitted at the point of supply allows a flexible hose to be safely isolated in the event of leakage.
- If you modify a system, inform your classification society. Better safe than sorry.

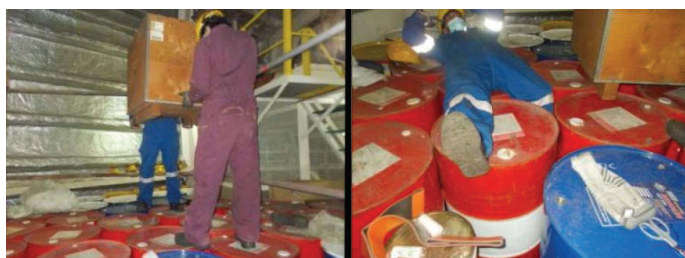
→ A tanker was in port, and two engine crew were to tidy up the steering gear compartment. Some empty wooden boxes were to be taken out. They were currently stored on top of various 45 gallon drums. The crew members climbed on top of the drums and were collaborating on lifting the boxes out when one crew member slipped and fell. He landed safely on top of the drums, but his left leg remained stuck in between the drums. With assistance, the victim was transferred to ship's hospital for evaluation of his condition and provision of first aid. He soon returned to the vessel and continued the recommended treatment onboard with light duties.

- Some unsafe conditions are in plain sight but become invisible because they are so familiar to us. In this case a commonplace task was not properly analysed for unsafe conditions.
- A deck full of holes is clearly unsafe; if you would not walk on a deck full of holes; why would you walk on a surface made of barrels that is full of holes?
