Mariners' Alerting and Reporting Scheme

MARS Report No 353 March 2022

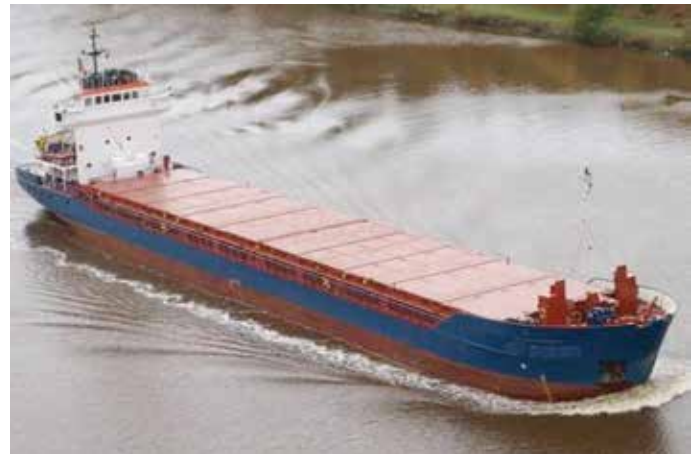
→ A small general cargo vessel with seven crew berthed to load a cargo of corn in bulk. Loading commenced after preparation and cleaning of the hold. The gas tight integrity of the hold was not tested before loading, even though it was intended to undertake in-transit fumigation after loading.

- By the time the vessel accommodation's forced ventilation was stopped, there was a positive pressure of fumigation gas in the hold. Stopping the ventilation and closing the ventilation flaps resulted in positive pressure being lost in the accommodation, allowing the fumigant to enter the accommodation via the sanitary ventilation system and, to a lesser extent, other entry points.

- Lack of effective physical barriers between fumigated cargo space and accommodation.
- When in-transit fumigation of cargo is planned, extreme care should be taken to assess the integrity of ventilation trunks, shared

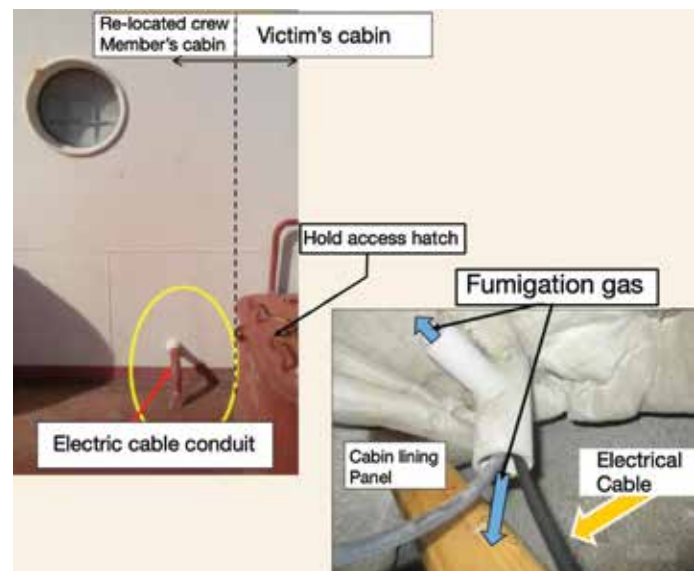
The next day, a phosphine gas reading of 2 ppm was measured at the upper deck alleyway. The Master called muster stations and instructed all crew to evacuate their cabins at once. The engine cadet did not appear at muster, so two crew went to his cabin where he was found in a state of partial paralysis. The victim was taken outside for care. A phosphine gas reading of 9 ppm was measured in his cabin, which was

The official investigation found, among other things, that a permanent access light for the aft access ladder of No. 5 cargo hold had been installed during construction. A conduit was used to run the electric cable between the accommodation and No. 5 cargo hold. The conduit ends were not sealed, contrary to best practices and classification rules. This defect allowed the phosphine gas to infiltrate the accommodation area and enter the crew cabins.

- As in the previous report, MARS 202209, the suitability of a vessel for fumigation is a critical factor and could mean the difference between life or death. In this case a 'man-made' defect rendered the vessel unsuitable for fumigation.
- Deadly fumigation gases can take several days to infiltrate accommodation areas, even when a clear passage exists, as in this case. Continuous or very frequent testing is the best defence against this danger.
