MARS – Lessons Learned

MARS Report No 370 August 2023

MARS 202334

Cargo fire takes 10 days to extinguish

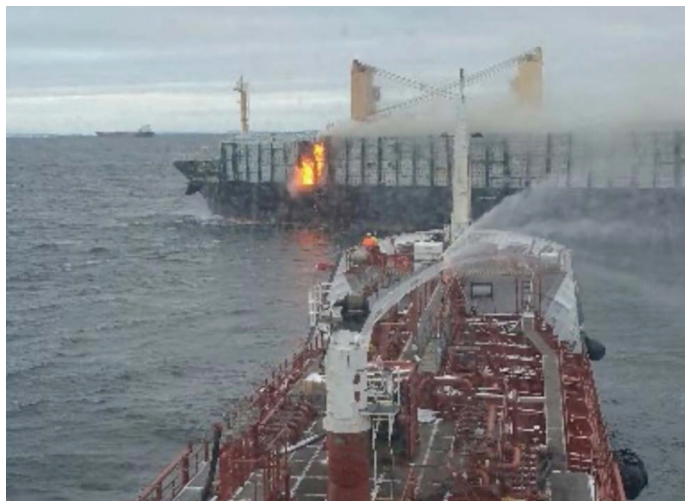
The official investigation found, among other things, that the extension cable that broke while undocking was probably live when the fire started. Although a circuit breaker normally trips rapidly if there is a direct metallic connection between two conductors, if the

current is passing through an electric arc and electrical conductors with substantial impedance (electrical resistance), the current may be too low to trip the circuit breaker. So, in all probability, an electric arc had come into contact with the plastic packaging or the wood and eventually ignited the material.

- Any situation where potentially 'live' circuits or wires are exposed should be corrected with the briefest of delays.
- The management of this vessel fire was one of the most extensive operations of its kind in modern times for Sweden. Among other things, the investigation revealed that multiple and overlapping responsible agencies needed to cooperate, but no protocols had been established prior to the emergency.
- The management of ships in need of assistance must be robust. Prior planning for all contingencies should be undertaken by a wide swath of concerned agencies including at the local, municipal and federal levels.

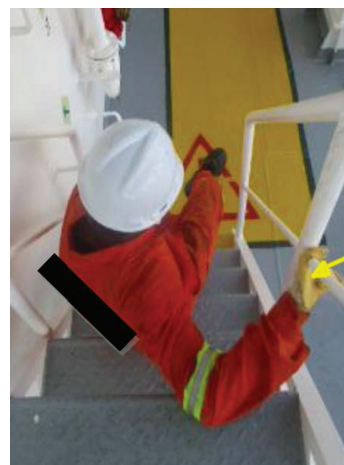
→ A vessel underway at sea was experiencing some rolling under heavy weather conditions. Crew were undertaking normal housekeeping duties. A crewmember slipped while descending a staircase and, with only his right hand lightly gripping the handrail, his efforts to stabilise his body were ineffectual. His small finger was bent back and sustained injury on the vertical post as he fell.

The company investigation found that although he had proper Personal Protective Equipment (PPE), his method of descending was suboptimal, in that, with only one hand on the right handrail, he was ignoring the good practice of having 'three points of contact' at all times. Risks were also more acute due to the rolling of the vessel.

- Everyday tasks and movements can appear less risky over time due to familiarity. Don't let your guard down!
- It is good practice to have a firm grip and use both hands on each handrail while using a staircase.
- **Editor's note** I am personally aware of another incident where an outside staircase had become more slippery over time as the anti-slip paint was gradually worn away. The gradual nature of the wearing away had led the crew to 'adapt' their behaviour and they all took great care while using the staircase – but hadn't yet thought to redo the anti-slip paint! When an outside party came to audit the vessel, she fell on that very staircase due to it being wet and slippery. Luckily, she was not badly injured.

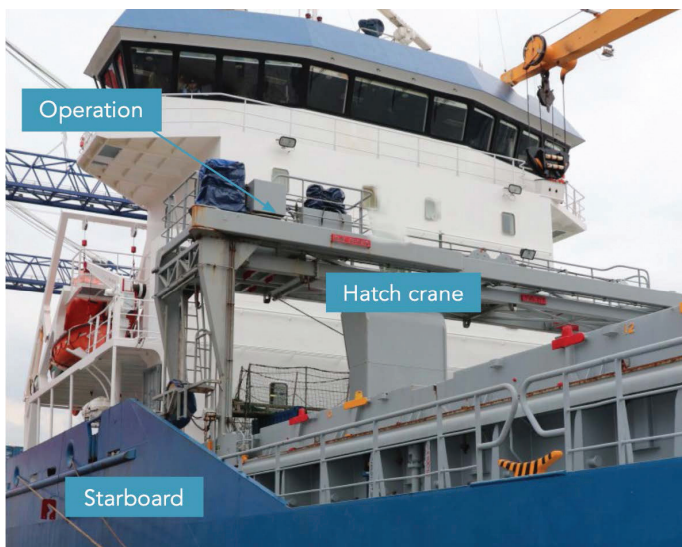
- The crane operator's field of view is severely restricted and does not allow a proper overview of both sides of the crane's track.
- The vessel layout allows persons to cross the track of the gantry crane.
- Communication with others is essential for determining if the hatch crane can be operated in a safe manner. Yet, this introduces the risk of miscommunication which was a contributing factor in at least one fatality.

Various measures have been adopted to control bad outcomes, but these appear to still have unacceptable residual risks. For example, having alarms continuously sounding while the crane is operating is well-intended – but they can become routine. Their efficacy will probably decline with time as crew become desensitised to the alarm and qualify it as 'normal'.

Emergency crane stop buttons are now a common installation. Yet analysis found that in many past occurrences the emergency stop button was not used because it was out of the victim's reach.

- Never cross the gantry crane rails while the crane is in use. If it is necessary to cross the rails, the crane should be stopped.
- Unrelated work on deck or in the holds should not be scheduled while gantry crane operations are taking place. If schedules clash, one or other of the operations should be rescheduled.

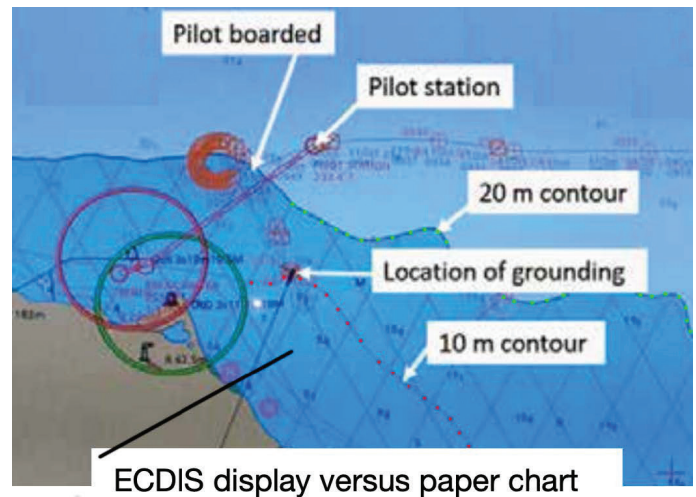
ECDIS display versus paper chart

The pilot was not monitoring the radars or ECDIS. Some minutes later the vessel ran aground while making about 3 knots. The bridge team did not realize immediately what had happened. Shortly thereafter, the pilot checked the radar for the first time and realized the vessel was aground.

The official investigation found, among other things, that although there had been a brief exchange of basic vessel information (horsepower and stopping capability) between the Master and the pilot, there was no exchange of passage plans or discussion of the approach to the berth. The pilot did not discuss his intended circular manoeuvre to reposition the vessel for its approach to the port, and the Master did not ask about the pilot's intentions. Furthermore, the Master did not communicate with the pilot the information that he was gathering from the ECDIS and radar, including course, speed, and the rapidly approaching depth contour on which the vessel grounded. Information exchange throughout the pilotage operation was limited to the pilot's helm orders. The pilot did not request feedback from the bridge team, and none was offered.

- Without electronic validation or input from other bridge team members, even an experienced navigator can make errors that can lead to bad outcomes if left uncorrected.
- The 'challenge' is a key principle of good BRM. When one member of the bridge team sees a developing dangerous situation, it must be communicated to the person having the con.
- In this case, the ECDIS shading was set to depict anything shallower than 20m in dark blue, to differentiate it from deeper waters, which were identified with light blue. Had waters with a depth of 10 metres and less been shaded with dark blue and marked distinctly as a no-go zone, the vessel's relatively rapid approach to the 10 metre depth contour would have been more apparent.
