Seaways

The International Journal of The Nautical Institute

MARS Report No. 291 January 2017

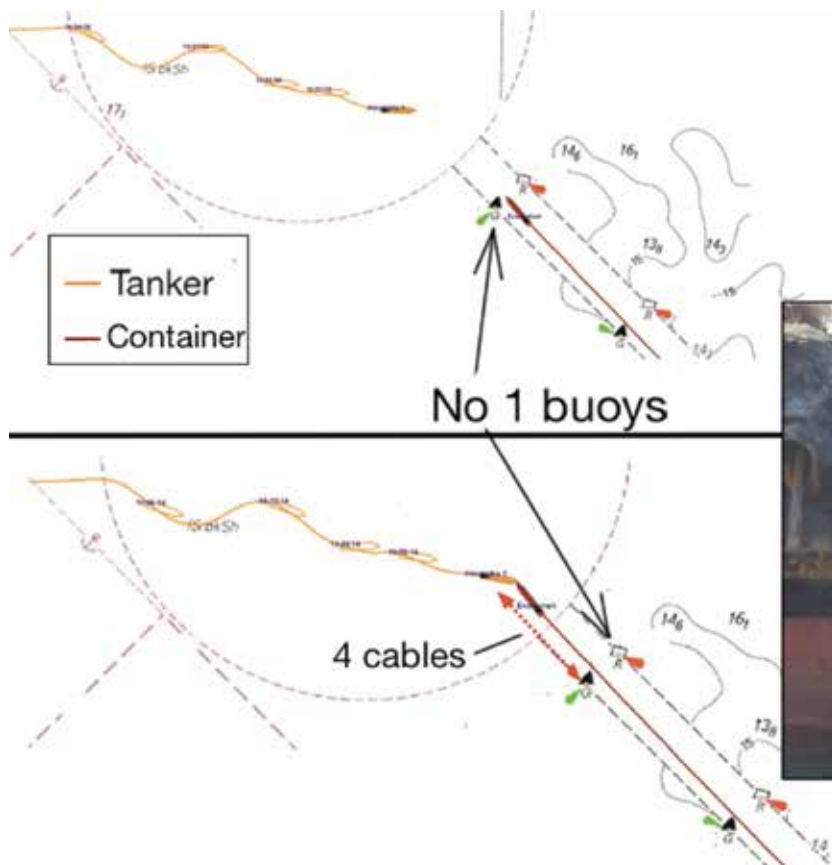
As the container vessel passed between the No. 1 buoys its speed was about 11kt. The tanker's Master saw the outbound container vessel pass between the No. 1 buoys and became concerned that the vessel had not altered to port as he had expected. He called VTS port control on the VHF radio to inquire. At this point, the pilot was still on the launch after having left the container ship. Shortly thereafter the two vessels, now both 4 cables from the entrance to the buoyed channel and near the centreline, collided bow to bow.

- The tanker Master's reliance on scanty VHF information and the failure of the container vessel's Master to keep a proper lookout and monitor the tanker's movement were pivotal to this accident.
- A lack of an agreed plan and absence of effective communication, co-ordination and monitoring were significant factors, which contributed to the flaws in both Master's situational awareness.
- On this occasion, the precautions of pilotage and port control, which should have been able to manage and de-conflict the vessels' movements, were ineffective.
- The pilot's failure to co-ordinate and communicate the passing arrangements for the two vessels was a significant omission; he was the assigned pilot for both ships. Although both Masters were aware of the other vessel, the plan for the meeting of the vessels remained ambiguous.

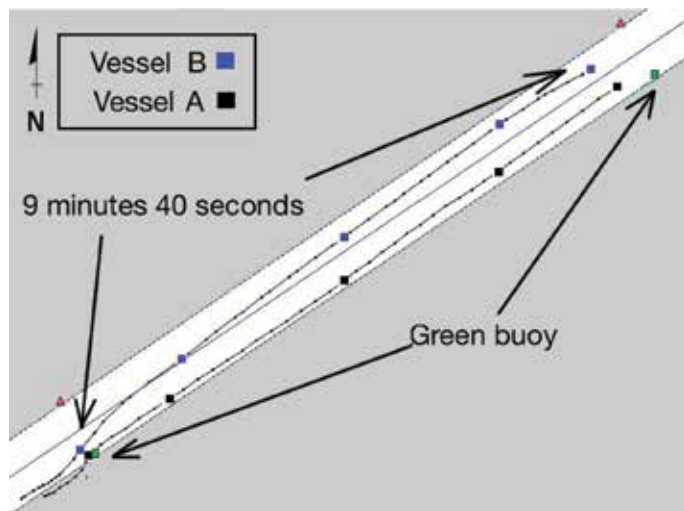
With the vessels closing, pilot B asked for full ahead, in an attempt to pull away. Notwithstanding this action, the two vessels collided, making parallel body contact about 9 minutes 40 seconds after the overtaking manoeuvre had begun.

- Neither pilot appreciated early enough the strength of the hydrodynamic forces at work, nor the need for early and decisive action to prevent the vessels from drawing together.
- Ineffective bridge resource management and poor communication between the vessels prevented both bridge teams from recognising the developing situation and taking timely action.

- When in the confines of a narrow channel, hydrodynamic forces between vessels are greater than when in open water due to the reduced flow capacity around the vessels and through the channel.

- When two ships pass or meet in the confines of a narrow channel, the squat experienced by each vessel increases by a considerable percentage.
- Hydrodynamic forces experienced by the vessels are proportional to the speed of the vessels through the water and inversely proportional to the distance between the vessels and the under-keel clearance of each vessel.

- The overtaking ship's resistance increases once past the overtaken ship, and the latter's resistance decreases. This can lead to a 'trapping situation' for the overtaking vessel.

- It is difficult to predict the onset and magnitude of hydrodynamic forces in the confines of a channel when manoeuvring large vessels.
- The hydrodynamic pressure zones around vessels can extend farther than the 100 metres commonly assumed.
